## Optima® EAF-150 Faucet

### PARTS LIST—EAF-150 FAUCETS

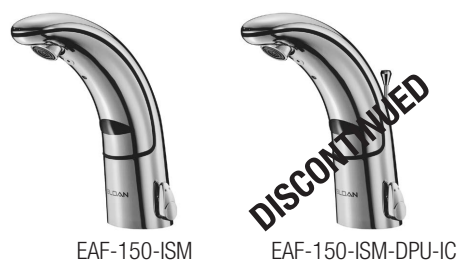
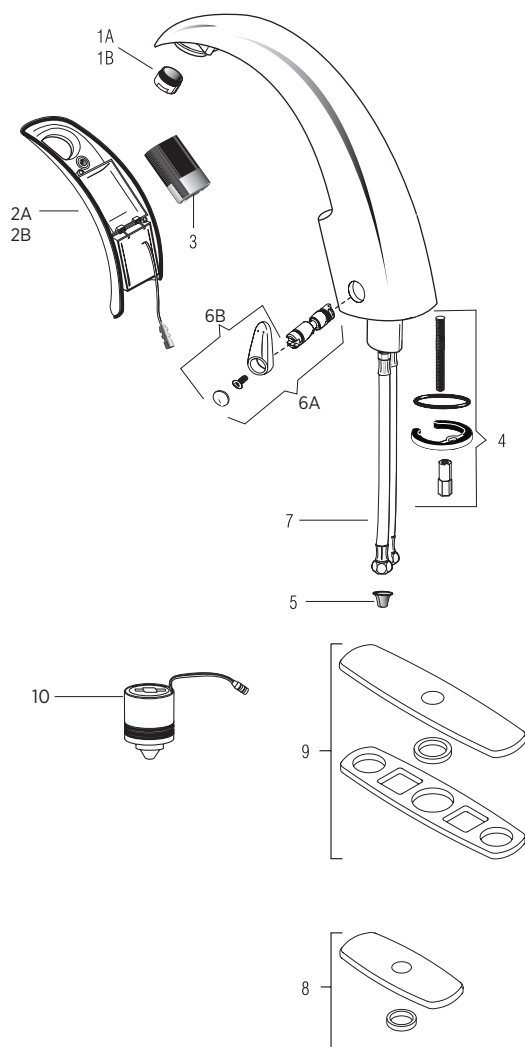
| Item No. | Code No. | Part No. | Description |
| 1A. | <b>0335008</b> | EAF-10 | 2.2 gpm (8.3 Lpm) Aerator Spray Head |
| 1B. | <b>0335010</b> | EAF-12 | 0.5 gpm (1.9 Lpm) Spray Head (Multi-Lam) |
| 1C. | <b>0335029</b> | EAF-51 | 0.35 gpm (1.3 Lpm) Spray Head (Multi-Lam) |
| 1D. | <b>0335021</b> | EAF-22 | 1.5 gpm (5.6 Lpm) Aerator Spray Head |
| 2A. | <b>0335002</b> | EAF-3-A | Throat Plate Assembly (Battery Models)<br>(from Nov 2018) |
| 2B. | <b>0335003</b> | EAF-4-A | Sensor standard throat plate assembly with i.q.<br>click (IC variation) |
| 3. | <b>3335009</b> | EAF-1000 | Battery Replacement Kit<br>(6V 2CR5 with 2.5 mm allen Wrench) |
| 4. | <b>0335000</b> | EAF-1 | Faucet Mounting Kit |
| 5. | <b>0335007</b> | EAF-9 | Strainer (Filter) 2 required for ISM Models (one per<br>package) |
| 6A. | <b>3335118</b> | EAF-1022 | Mixer Handle Assembly and Cartridge (post 2004) |
| 6B. | <b>3335011</b> | EAF-1002 | Handle Repair Kit |
| 7. | <b>3335023</b> | EAF-1008 | 15" (330 mm) Flexible Supply Hose (1) with inlet<br>filter |
| 8. | <b>0362011</b> | SFP-11 | Trim Plate for 4" Center-set Sink |
| 9A. | <b>3365303</b> | ETF-608-A | Trim Plate for 8" Center-set Sink |
| 9B. | <b>3362022</b> | SFP22A | Trim Plate for 8" Centerset sink |
| 10. | <b>0335001</b> | EAF-2 | Solenoid (6 mm hex recess) |

Solution: Replace sensor throat plate; see parts breakdown on next page for correct sensor throat plate replacement (item #2B).

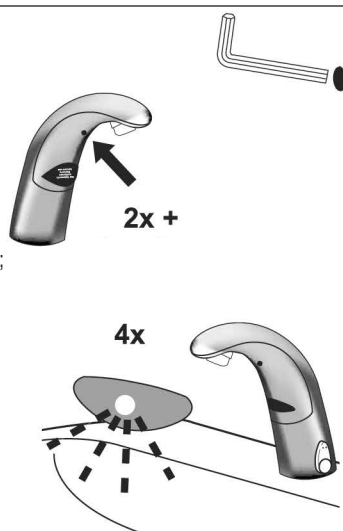
### MANUAL RANGE ADJUSTMENT

To manually change range, press and release iq button 2 quick times, wait for rapid "temporary off" red LED flashes, then press and hold iq button, there will be four (4) red LED flashes, a pause, then more red LED flashes (up to eight (8) red LED flashes); 1-red LED flash for the shortest range setting, eight (8) flashes for the longest range setting;

Release iq button after desired red LED flash for range setting (#6 is factory setting).

After releasing button, faucet will cycle through auto calibration (approximately 15-seconds). Then test faucet.

1 x ( 1x, 2x,...,8x)

**NOTE:** Updated electronics have visible RED and GREEN LED. Original electronics have only RED LED and range setting is reversed (1 = longest, 8 = shortest)

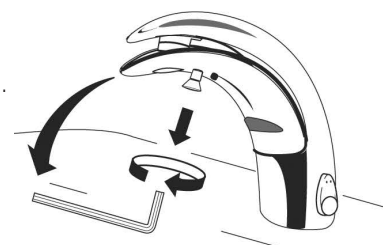
#### Step 2

Loosen screw with hex wrench.

Remove throat plate.

Disconnect electrical lead at connector if required.
